# OREM CITY HALL

## FEASIBILITY STUDY

March 04, 2021

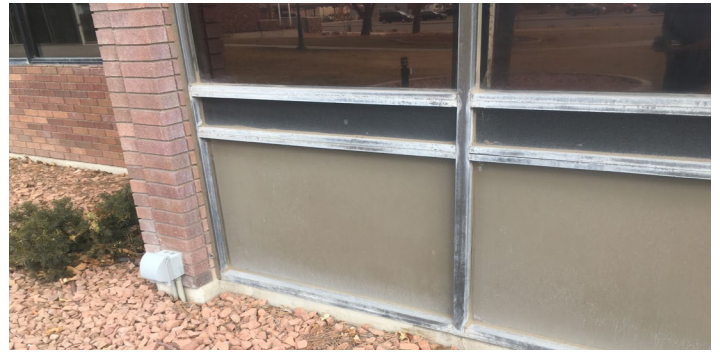
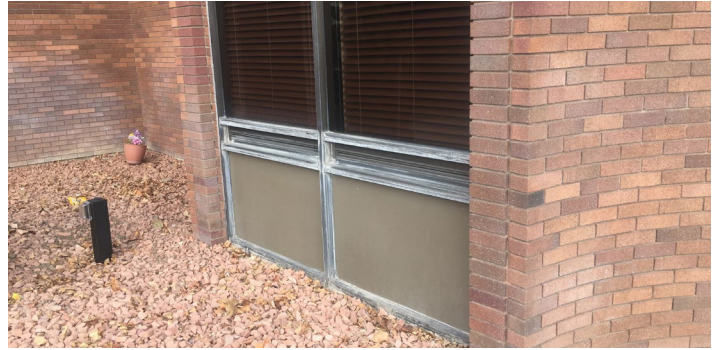
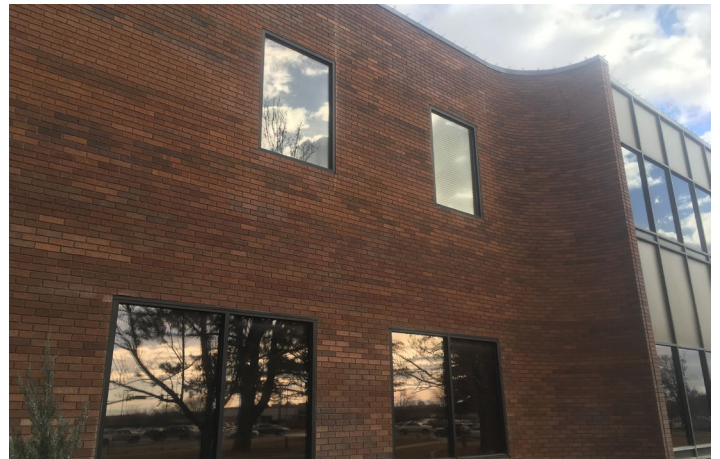
Condition of glazing seals and caulking are unknown. There are hard water deposits at all ground level windows due to site irrigation.

A few windows have been added to the building. The openings have been cut into the existing brick. Sealant has been applied for moisture protection. Performance of window and opening are unknown.

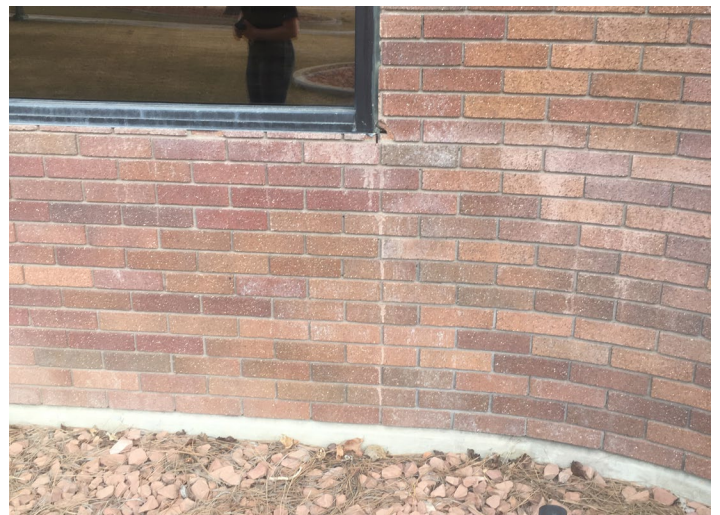
Much of the building exterior is brick. For the most part, brick appears to be in good condition. There is hard water staining from irrigation systems along the ground level. There is also some surface damage to brick where sidewalks directly abut the building.

Some additions and alterations have been made, including additions with similar brick. The additions are somewhat obvious due to slight color variations.

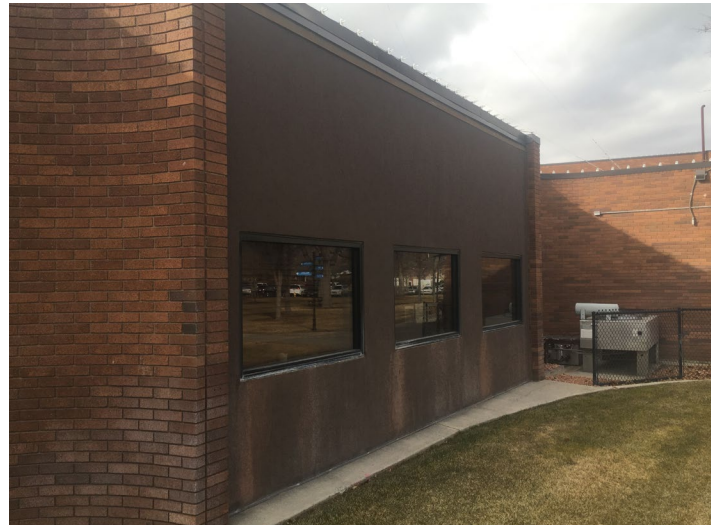
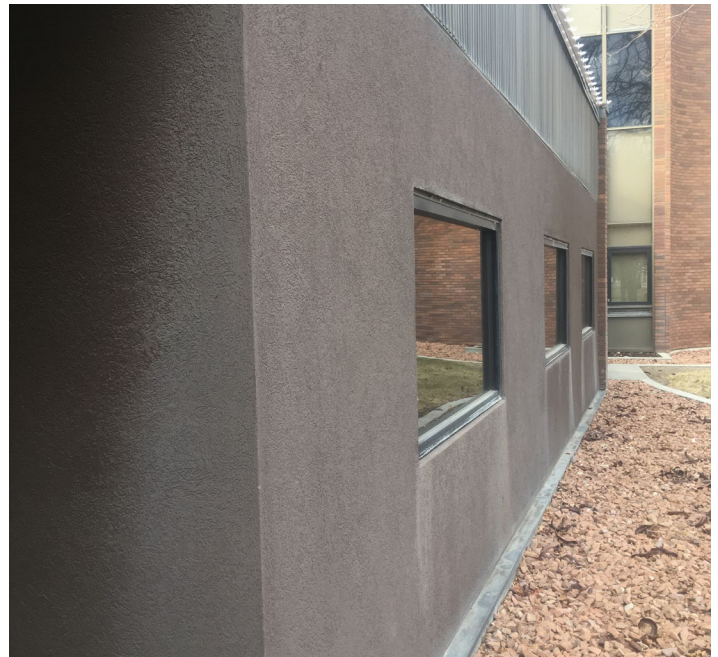
Stucco system appears to be an Exterior Insulation and Finish System (EIFS). Age and performance of the system is unknown. Water staining occurs along the lower portion of the walls potentially due to moisture draining from system around windows or to over spray from site irrigation. The staining is more pronounced at the window sill corners.

These EIFS areas are not original to the building. They were installed as the result of either a remodel of the building (upper right image), or an addition as shown in the middle image.

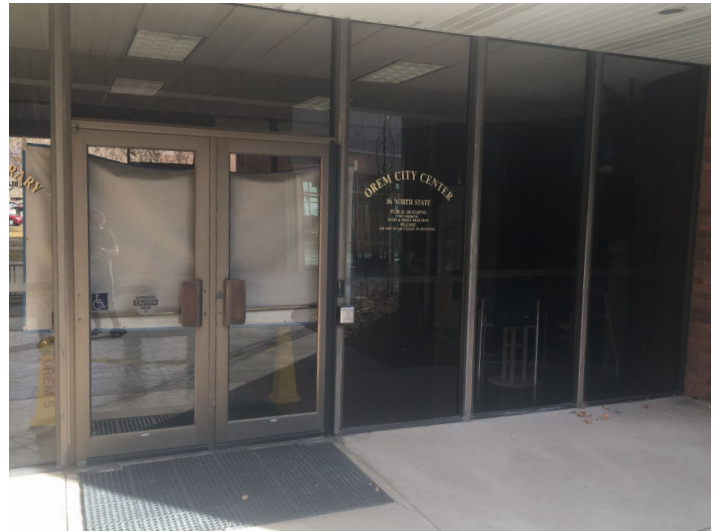
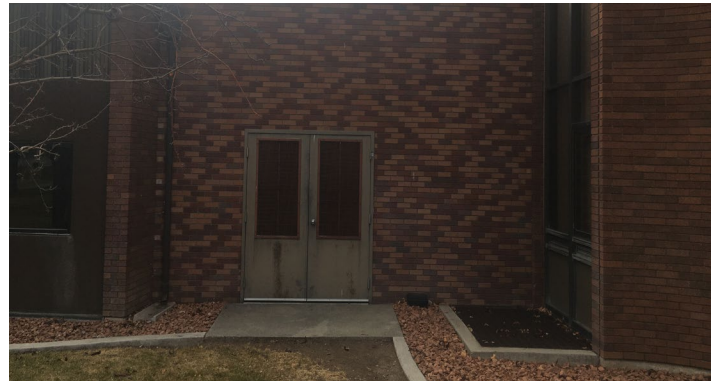
It appears that many exterior storefront type doors have been upgraded since the building was built in 1970. They seem to be in working condition, however, thermal performance is unknown.

There are also painted steel doors on the exterior, doors and frames have the potential for corrosion. Functionality and thermal performance of these doors is unknown.

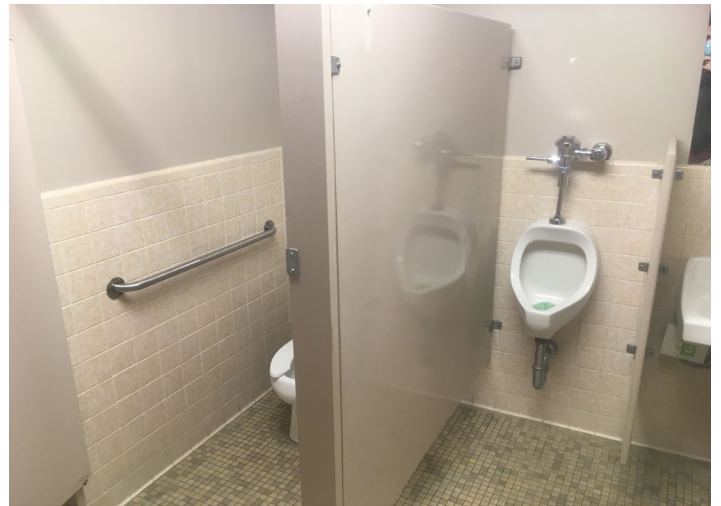
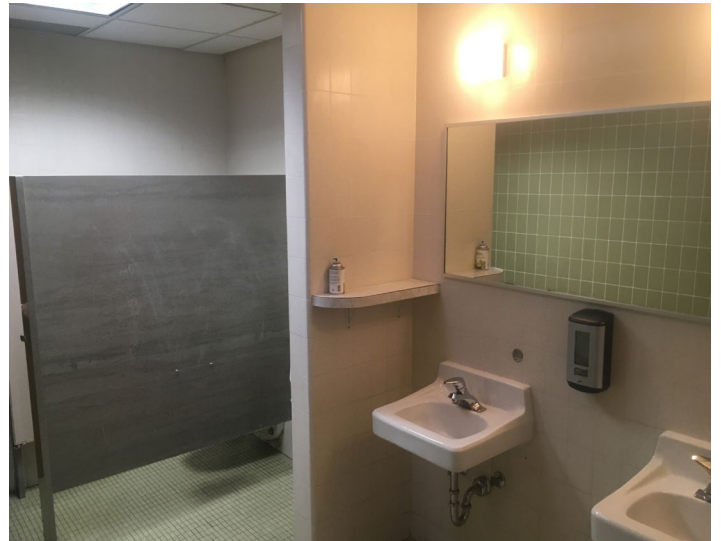
Restrooms are located on each level of the building. All of the restrooms have been modified since initial building construction to accommodate accessibility and access. Due to this, each restroom seems inadequate in sizing and layout.

The restrooms located in the basement are small and seem to be placed where ever they could fit. A more centralized set of restrooms would be a more efficient use of space.

The restrooms on the main level are currently being remodeled to provide accessibility and update plumbing fixtures and room finishes.

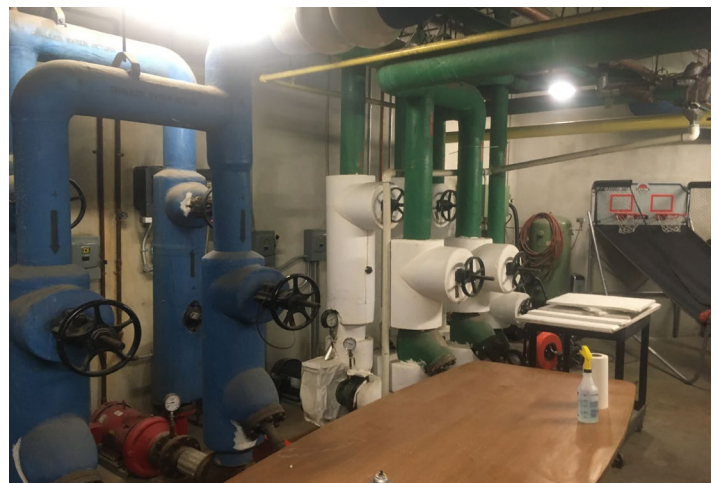
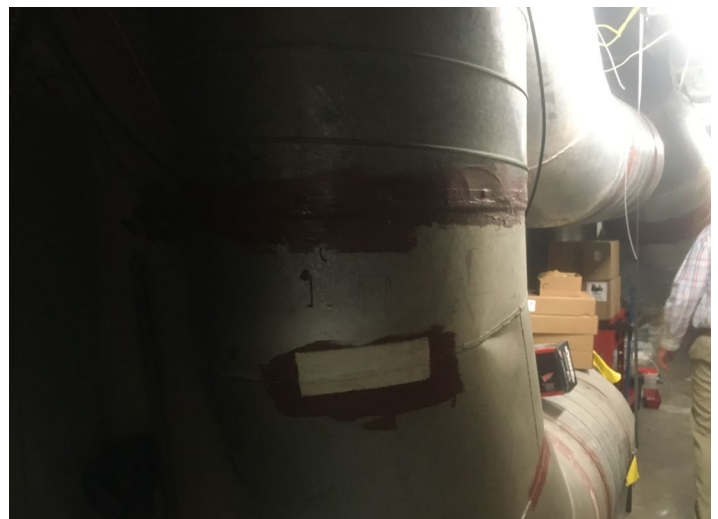
New heat pumps were installed and vfds added to the system in 2010. This was done to increase energy efficiency.

Cooling pumps were replaced in 2010, and vfds were added to increase energy efficiency.

The cooling tower was replaced in 2000 with a bac tower. Due to vfds being used to save energy, the varying condenser water flow over the cooling tower media can cause water treatment issues.

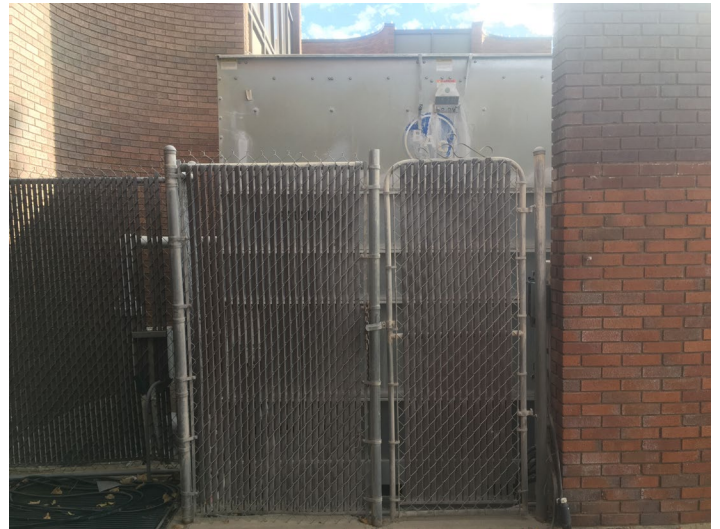
With the air handlers located in the basement level, there are numerous air intakes and/or exhaust grills at the ground level, just outside the building. They are located at the East, West, and South areas.

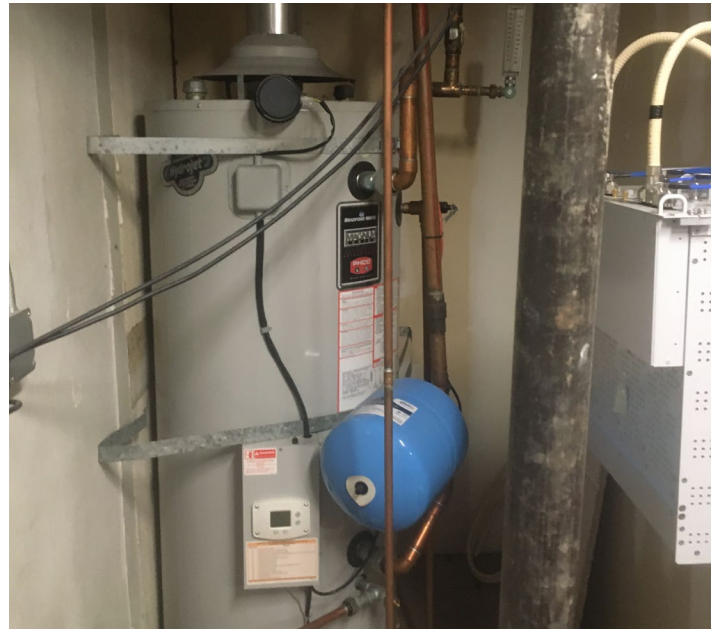
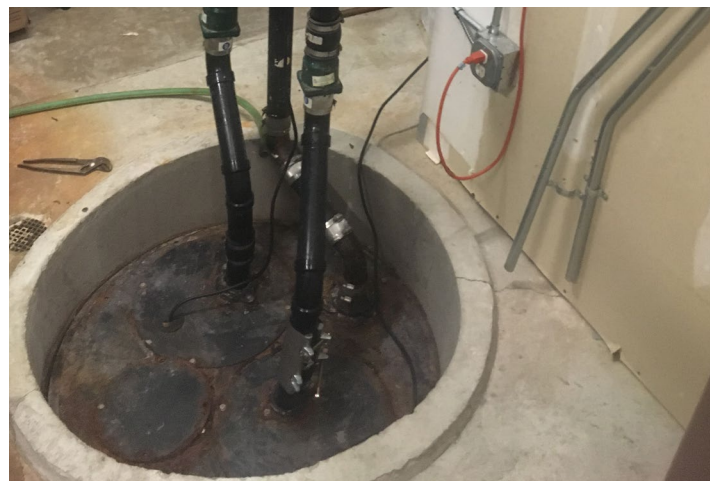
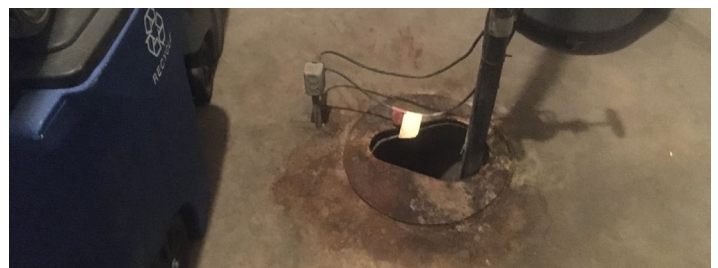
VBFA noted that the cast iron sewer has leaks

The water is supplied through galvanized pipes. Water pressure at that time was adequate for fixtures. VBFA pointed out that corrosion can form in galvanized piping and cause pressure issues. But that was not the case.

There are two sewer ejector pumps for the basement. One located in engineering, the other in the I.T. Department. The pump was replaced sometime around 2016. The piping is cast iron, and there have been cracks in the past that have caused odors in the basement area. At the time of the VBFA report, there were no cracks in the piping or odor issues.

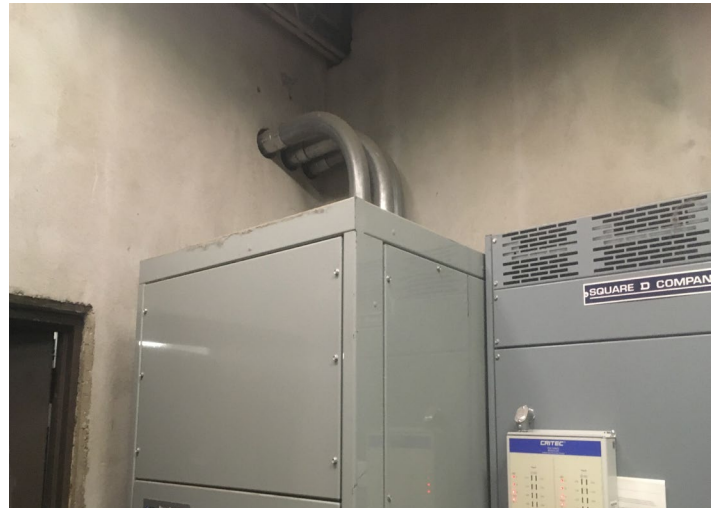
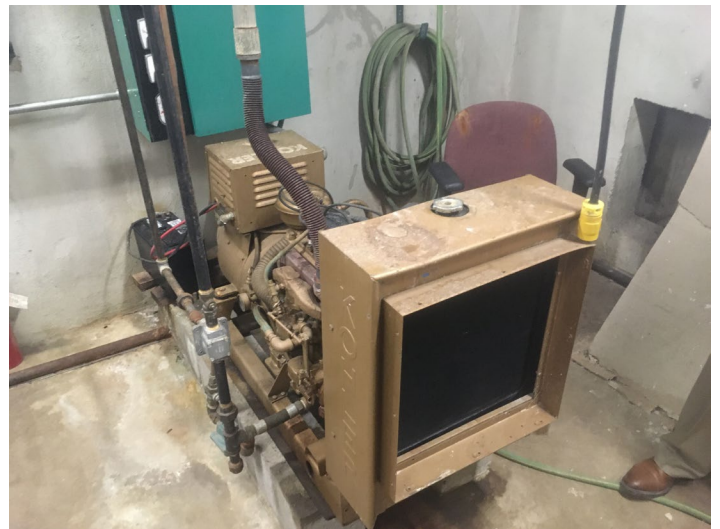
Metal smokestack/flue from basement up through roof. This was originally used to burn papers and documents. Currently is not being used and slated to be removed.

The existing 300kW emergency generator seems to have met its service life. The ventilation is inadequate, and could potentially overheat while accommodating a large electrical load. There is an underground fuel tank, approximately 4000 gallons buried to the east of the building. The condition of the tank is unknown, and could potentially be an environmental issue.

It was recommended that the old switchgear be replaced, due to the difficulty of acquiring parts and circuit breakers.

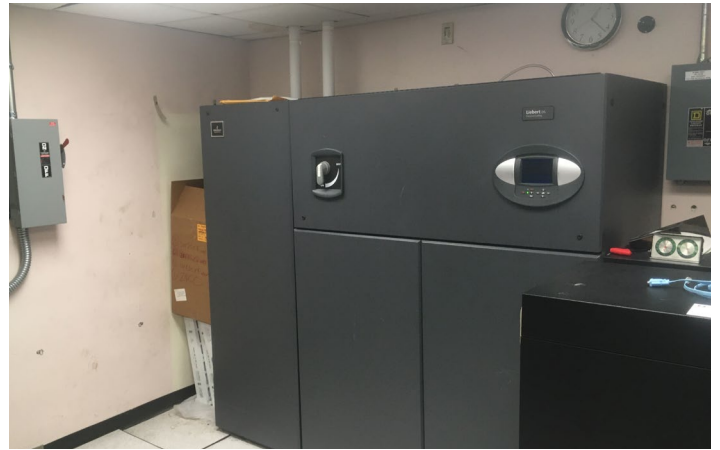
Servers are located in the basement. The room was not originally intended for this purpose. There are main water supply lines directly above the servers, and could potentially cause significant damage if a leak were to occur. The room has an elevated floor for cooling. The servers are next to office spaces, and sound isolation pads have been installed along walls and doors.

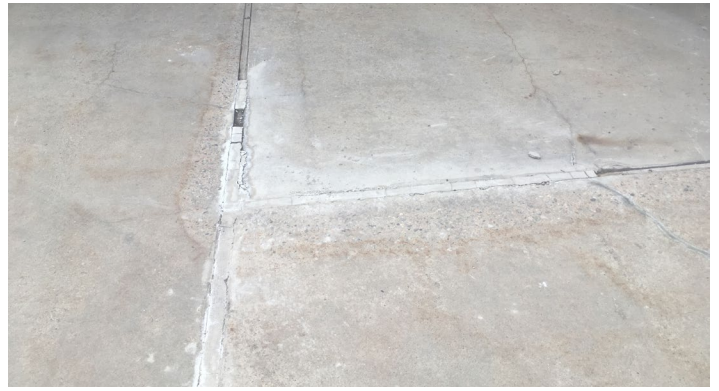
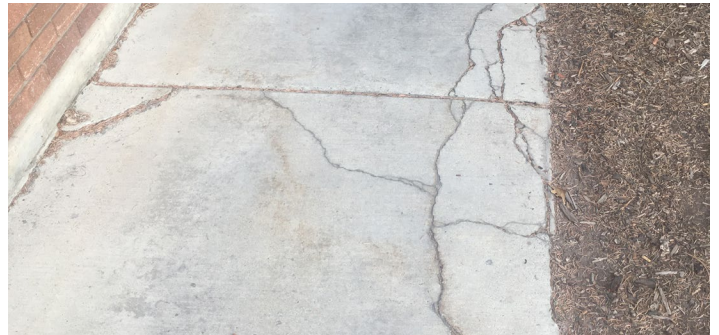
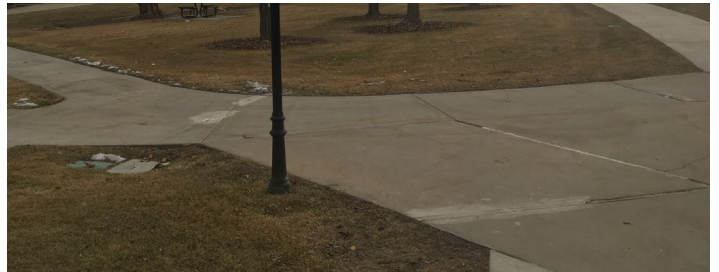
With the age of the building, sidewalks are comprised of sections poured at different decades. Other sections have been cut for site work and subsequently filled. Walkways intersect at different angles and directions. Some concrete pads have lumber around the perimeter. These areas have been filled over to remove tripping hazards. These repairs have since deteriorated and will need additional attention.

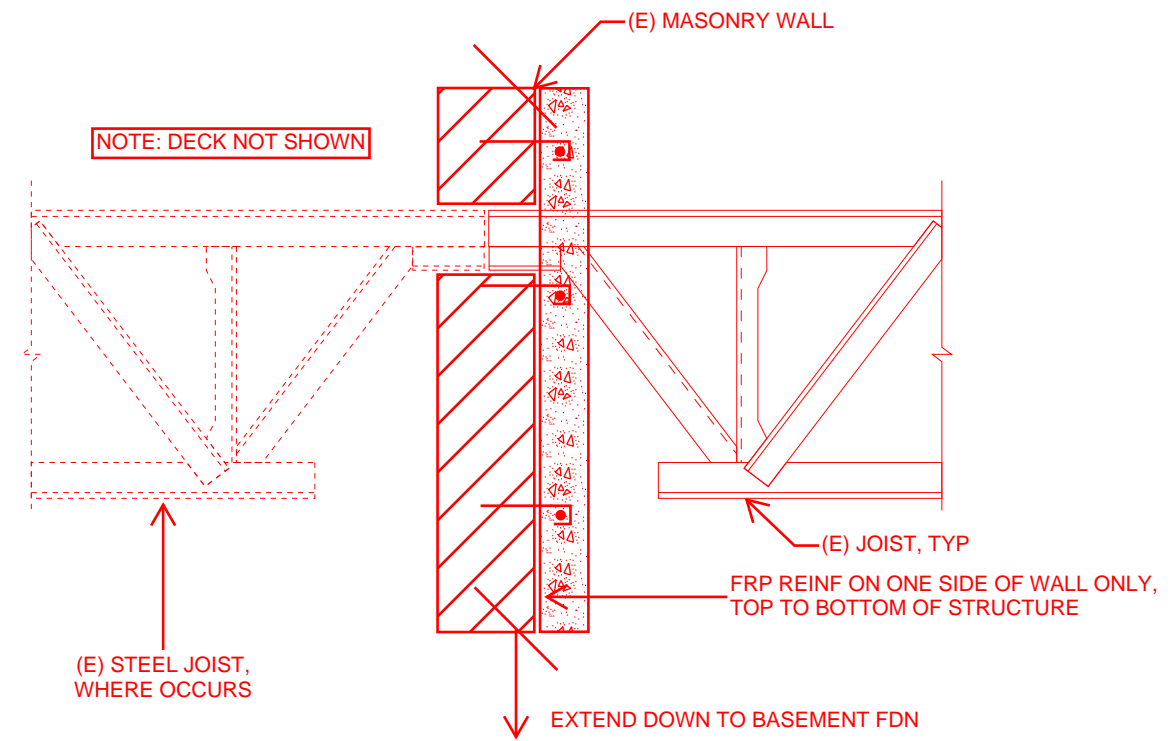
DETAIL 8 (AT (E) CLERESTORY MASONRY WALLS)

- The walls around the clerestory area in the mid-wing appear to not be tied together or reinforced properly. It is recommended to add new shotcrete walls with ties to the existing to reinforce and stabilize the walls. Alternatively, the existing wythes could be tied together with helical tie rods and by using FRP to reinforce the existing walls where additional reinforcement is required.

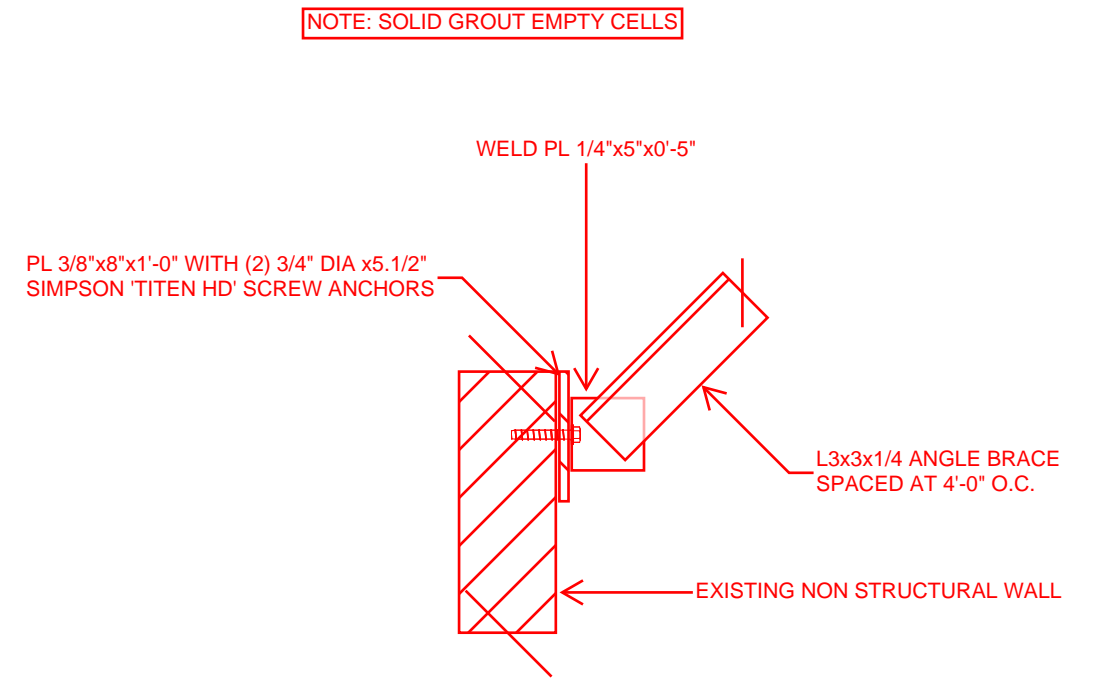
DETAIL 6 (BRACING OF NON STRUCTURAL WALL)

- There are several unreinforced masonry walls in the building. It is unknown how or if these walls were braced to the structure. Unreinforced masonry is a life safety concern in seismic events due to their brittle nature and collapse potential. All unreinforced masonry should be removed and replaced with stud framed partition walls anchored to the structure.
