# OREM CITY HALL

## FEASIBILITY STUDY

March 04, 2021

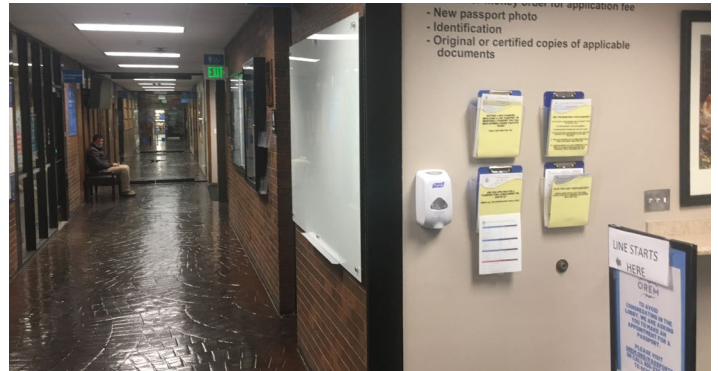
## BASEMENT:

The basement level consists of a labyrinth of hallways, ramps, stairwells, and sub-levels.

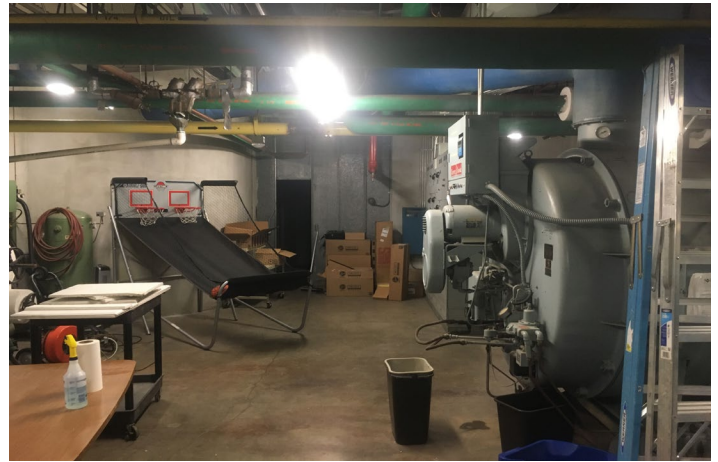
The building is served by a large, built up, dual duct VAV, air handling unit. The 1970 air handler unit is still in use, and most other major mechanical equipment has been replaced with updated units.

The cooling tower was replaced in 2000 with a bac tower. Due to VFDs being used to save energy, the varying condenser water flow over the cooling tower media can cause water treatment issues.

Ductwork and air terminals are all original equipment. Supply and relief fans are original. VFDs have been installed to control the fans as a VAV system.

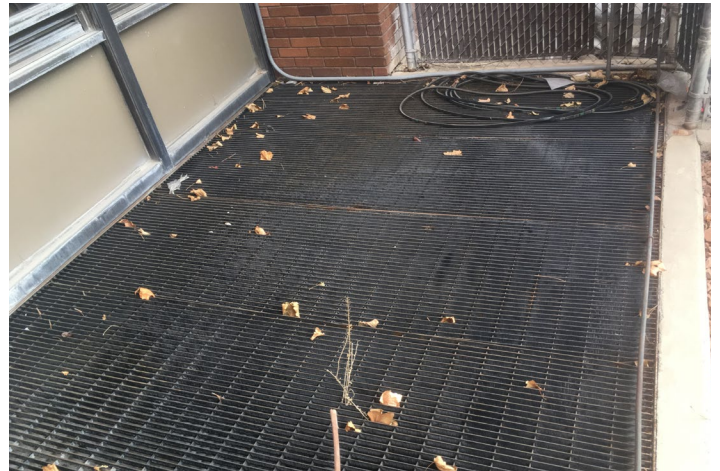
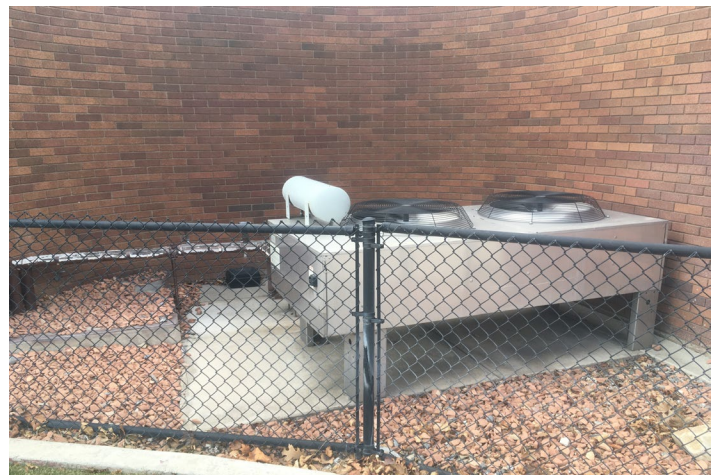
External HVAC equipment is at both the East and West areas of the building, just outside the building. It is unclear if there are any units on the roof.

With the air handlers located in the basement level, there are numerous air intakes and/or exhaust grills at the ground level, just outside the building. They are located at the East, West, and South areas.

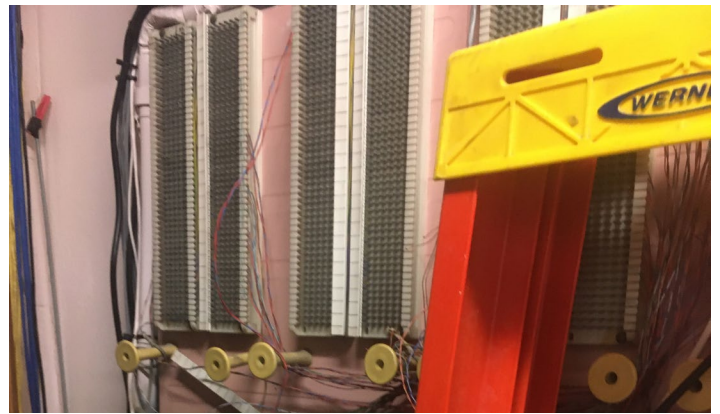
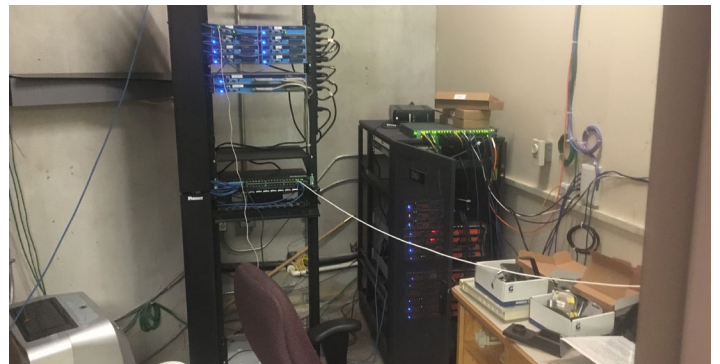
The main communications and data room is located in the basement. There are other smaller rooms on the main level that also serve as communications.

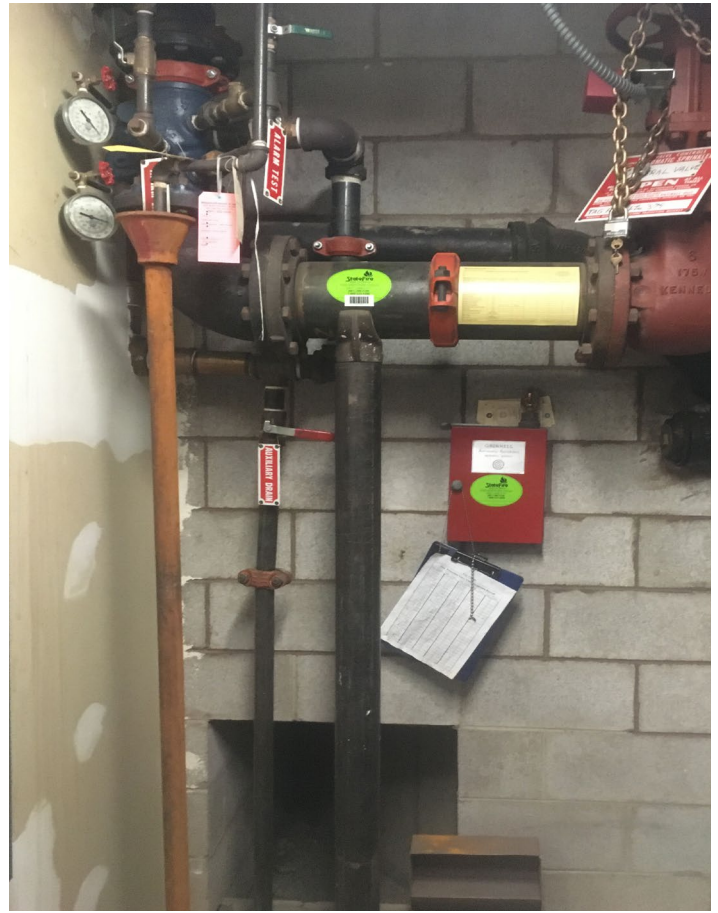
City Hall utilizes a pressurized fire sprinkler system. It appears to be functional. Age of system is unknown.

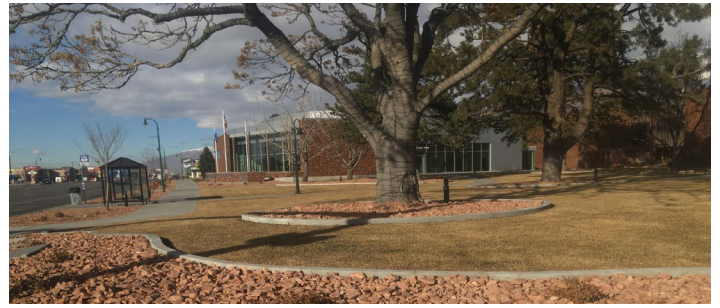
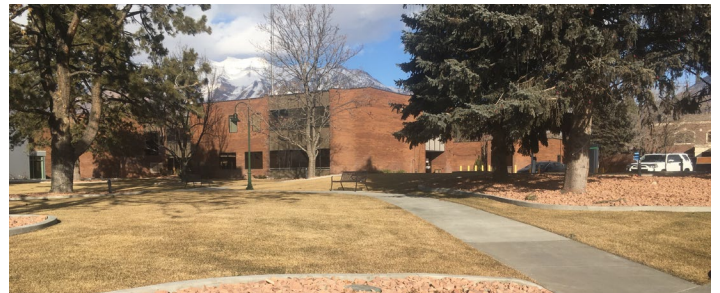
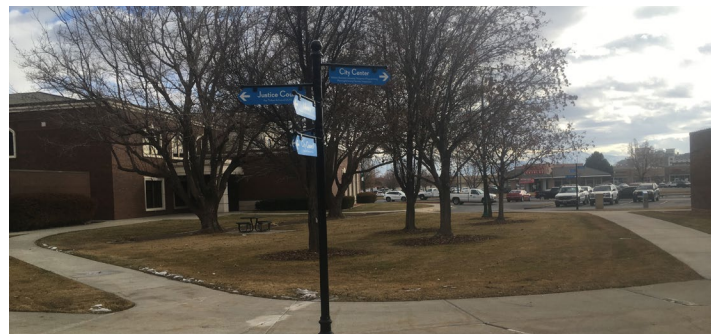
Trees located in the south west corner of the city center were planted in the late 1940's to early 1950's. These were here before city hall was built in 1969. There are also large trees located on the east side.

Much of the site is covered with sod. Areas around large trees and the South West corner are comprised of medium sized landscaping rocks. Concrete curbing separates the rock from sod.

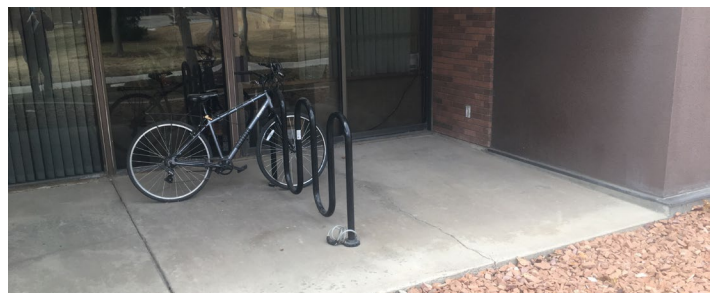
Two exterior bicycle racks are located on the East side of the building. One near the entrance between the Library and the City Council Chamber area of City Hall. It is easily accessible.

The other bicycle rack is located near the East entrance near Building Services on the main level and the stairwell entrance to the basement level. It is located underneath a covered patio, however, there is not a concrete or paved path to the area. Users need to cross landscaping gravel.

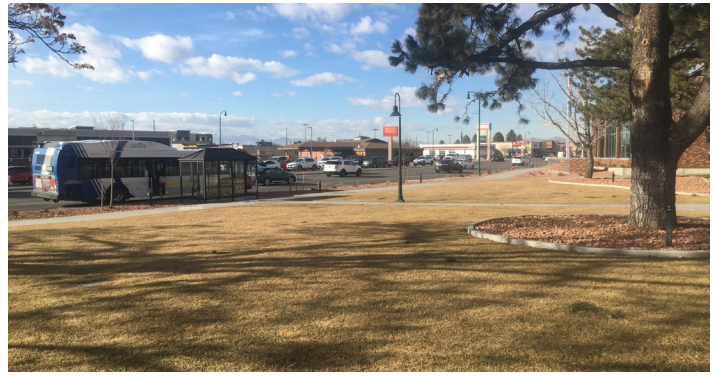
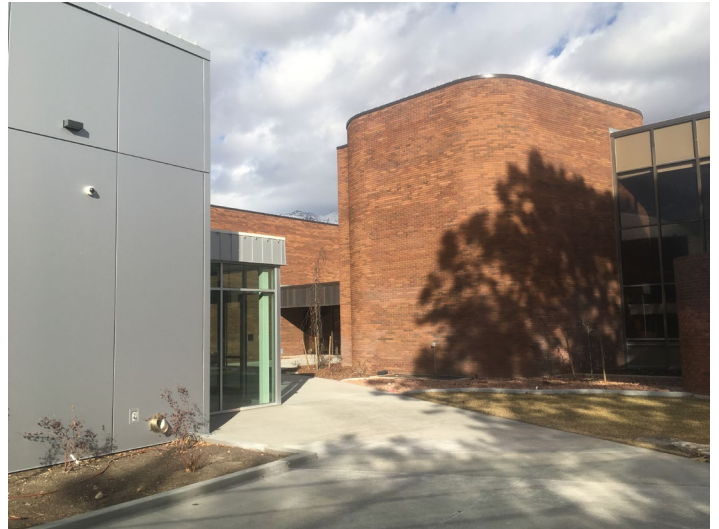
Accessing the building is possible on each exterior face. There is a public transit bus stop along State Street to the West of the building. Public using this route most likely would use the North entrance next to Library Hall, or the South entrance near the 311 Services area.

The main public parking lot is located to the North East of the building, and access to the building from this location occurs at the North end of the building next to the Library, or the East entrance near Building Services and Accounting.

Access to the South portion of the building can be from the public bus stop, or the South parking lot.

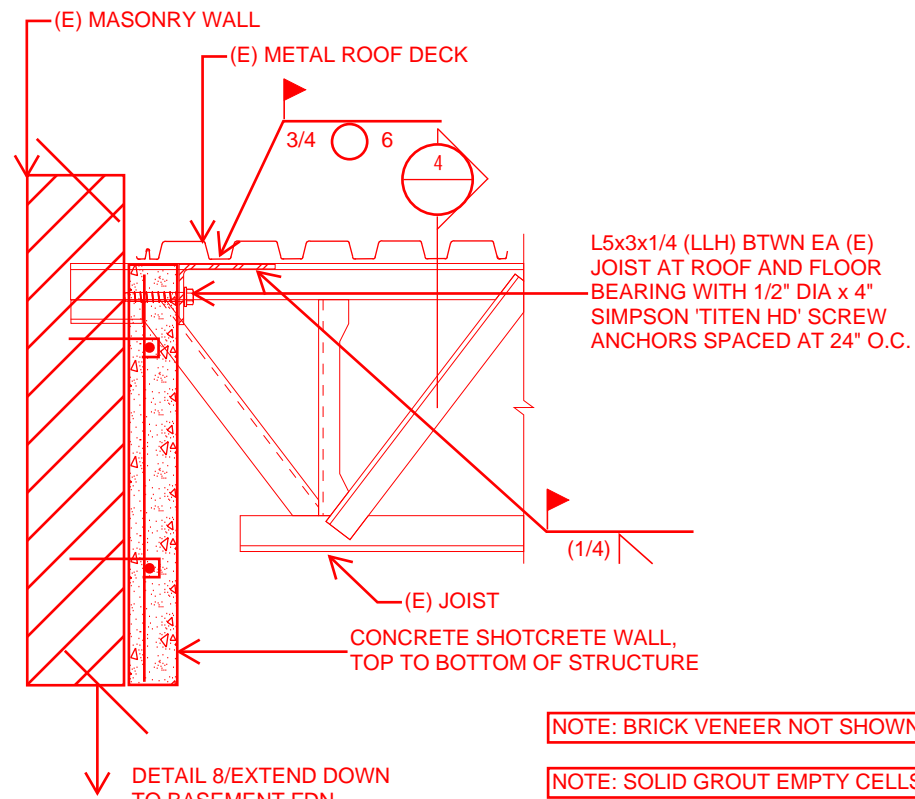
DETAIL 2 (AT (E) CLERESTORY MASONRY WALLS)

- The walls around the clerestory area in the mid-wing appear to not be tied together or reinforced properly. It is recommended to add new shotcrete walls with ties to the existing to reinforce and stabilize the walls. Alternatively, the existing wythes could be tied together with helical tie rods and by using FRP to reinforce the existing walls where additional reinforcement is required.
